STRESS CORROSION CRACKING OF ROCK BOLTS

Erwin Gamboa

A THESIS SUBMITTED TO THE UNIVERSITY OF QUEENSLAND
FOR THE DEGREE OF DOCTOR OF PHILOSOPHY

NOVEMBER 2004

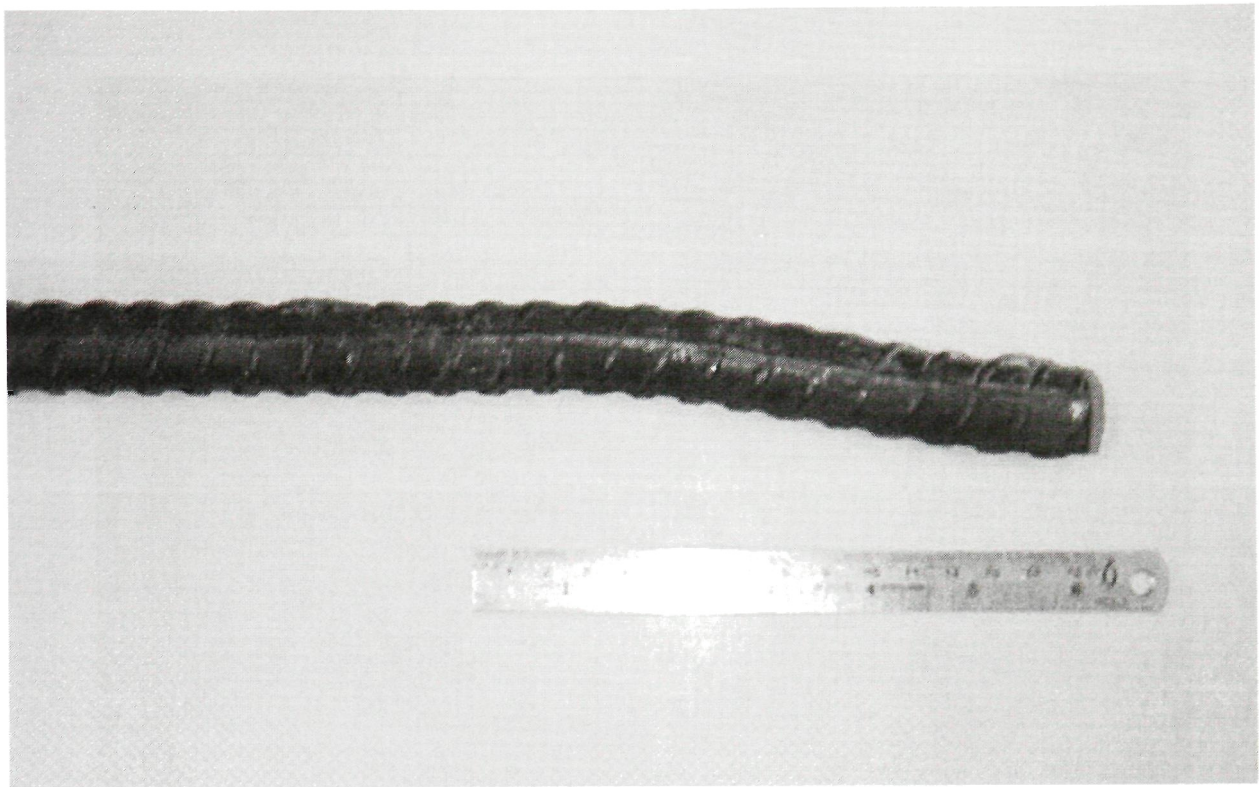
FIGURE 5.12: Macroscopic view of colliery W rock bolt. The fracture was at the right end of the bolt segment.

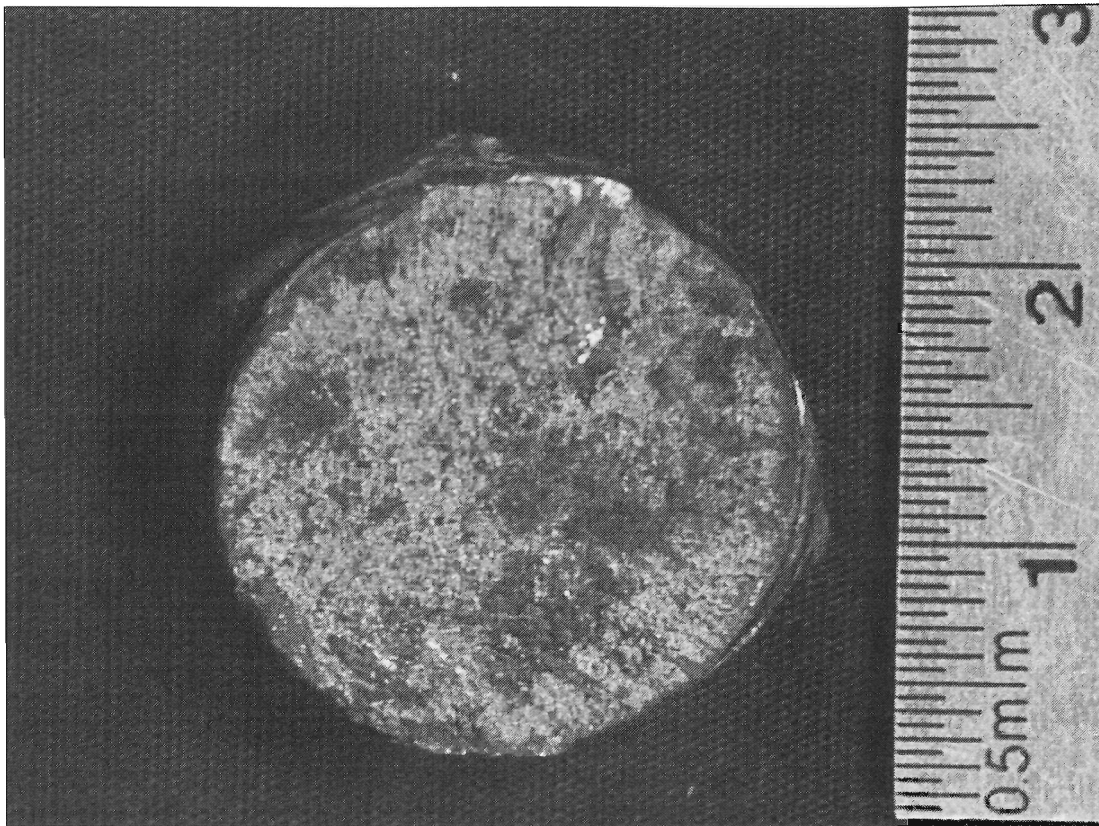
FIGURE 5.13: Rock Bolt fracture surface

(a) Macroscopic view of the bolt's fracture surface

(b) Schematic view showing SCC and fast fracture areas

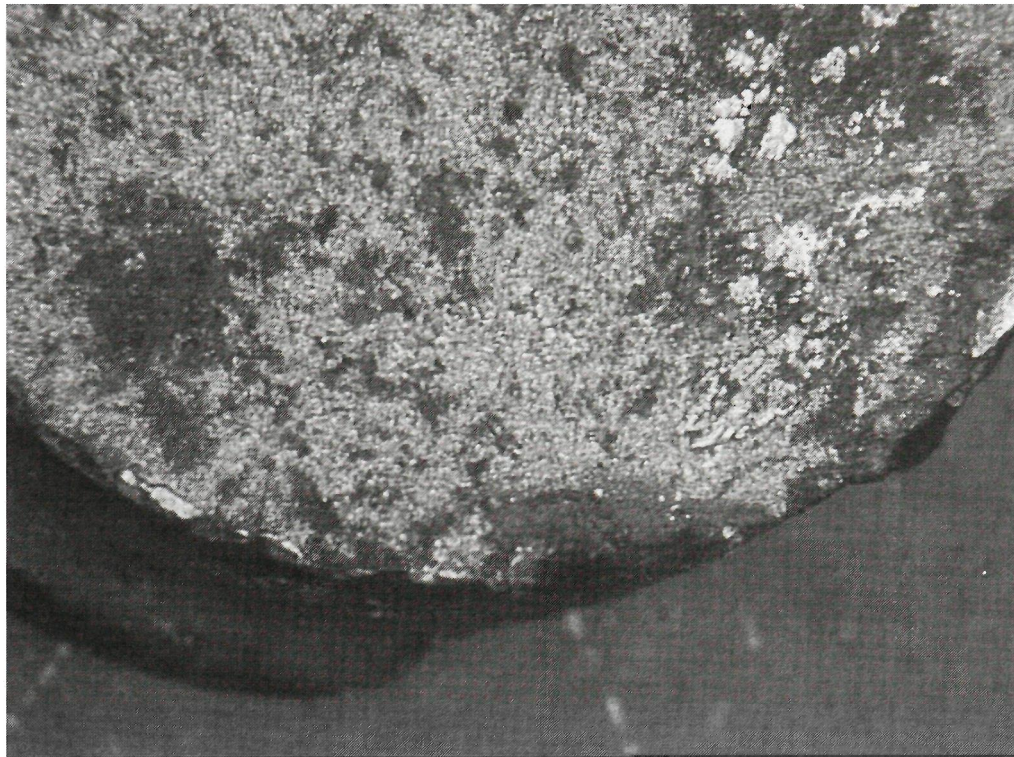
FIGURE 5.14: Rock Bolt fracture surface

(a) Higher magnification view of the bolt's fracture surface

(b) Schematic view showing carbon deposits and surface damage

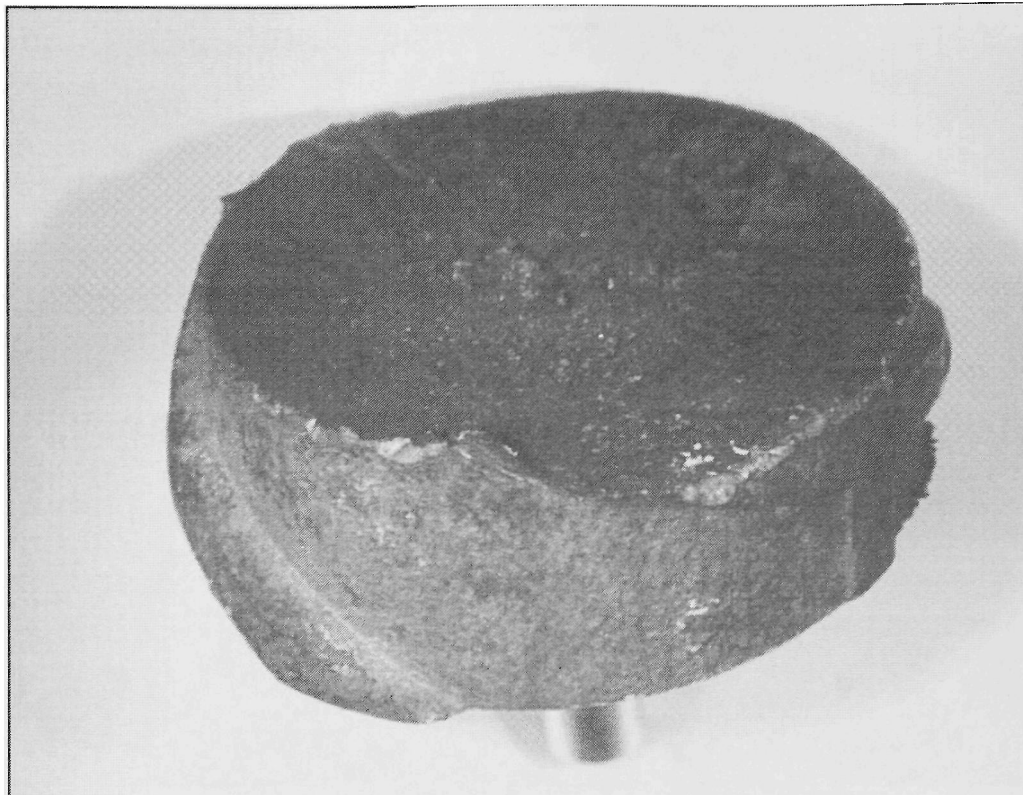
(a) High magnification photograph of the SCC area along the bolt rib

(b) Schematic view outlining SCC area, carbon deposits and surface damage

FIGURE 5.15: SCC along the foot of the bolt rib

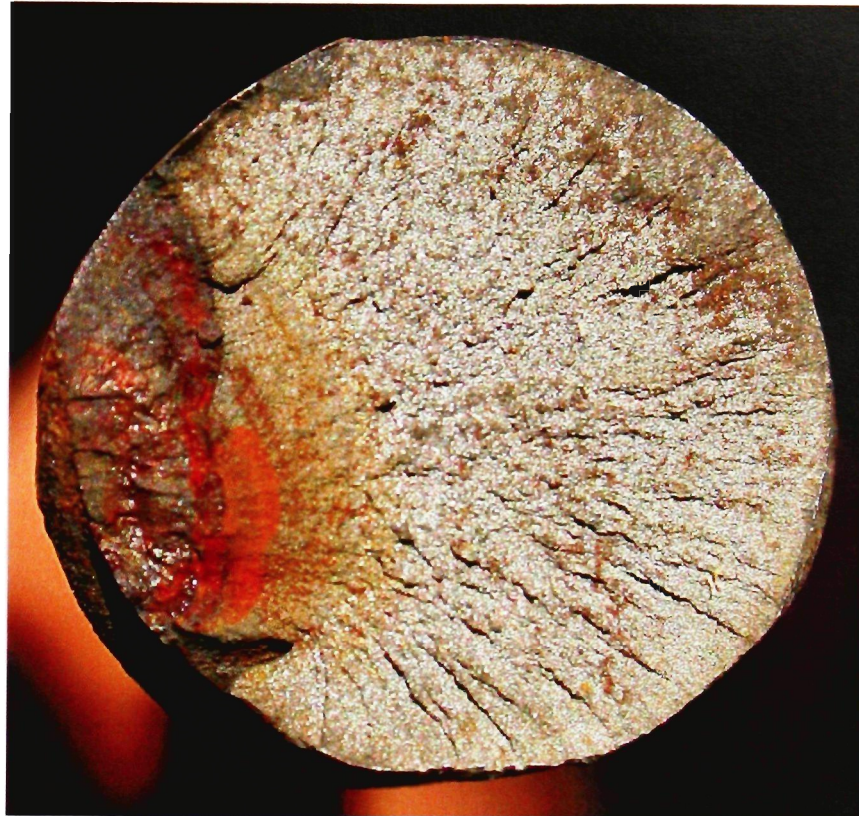
FIGURE 5.59: Rock Bolt fracture surface

(a) Macroscopic view of the bolt's fracture surface

(b) Schematic view showing SCC, tear lines and fast fracture areas

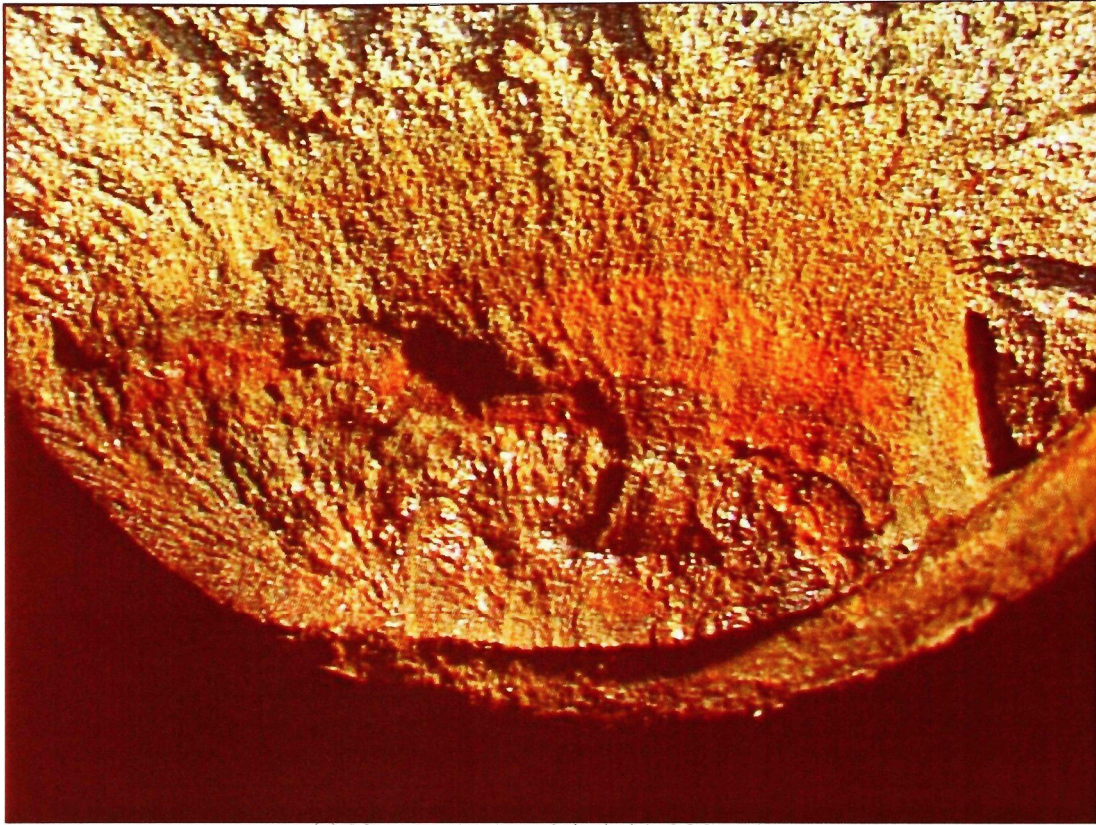
(a) Macroscopic view of the bolt's SCC surface

(b) Schematic view showing SCC and fast fracture areas

FIGURE 5.60: Rock bolt SCC overview

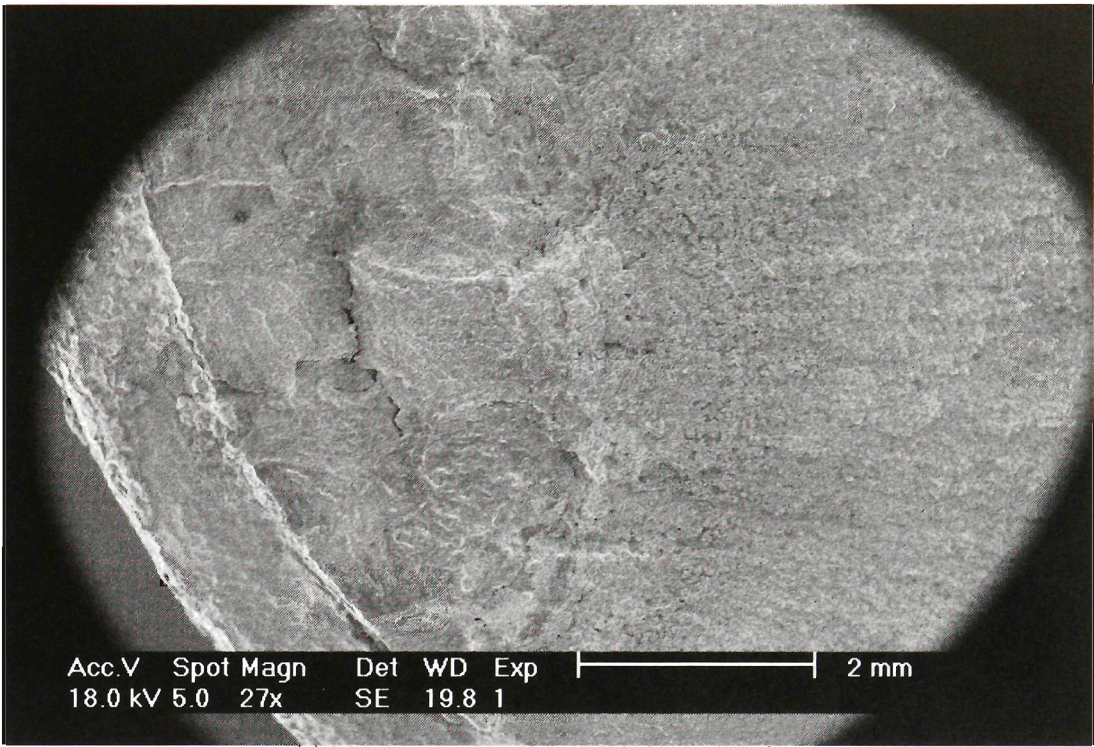
(a) Microscopic view of the bolt's fracture surface

(b) Schematic view showing bolt rib, SCC and fast fracture areas

FIGURE 5.61: Rock Bolt SCC overview

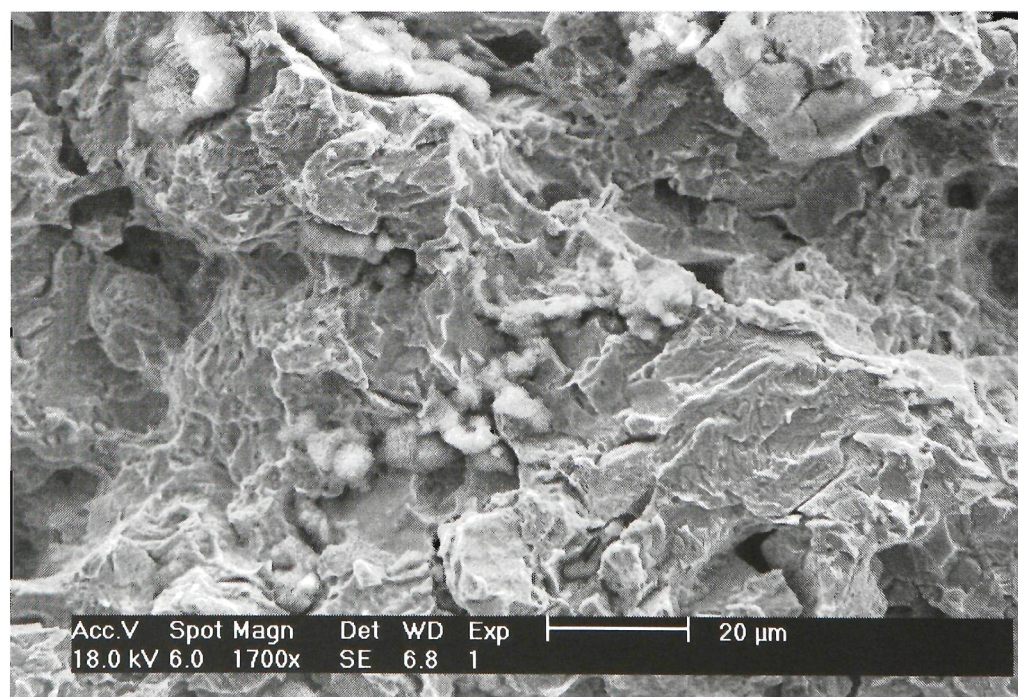
FIGURE 5.63: Typical SCC topography (damaged)

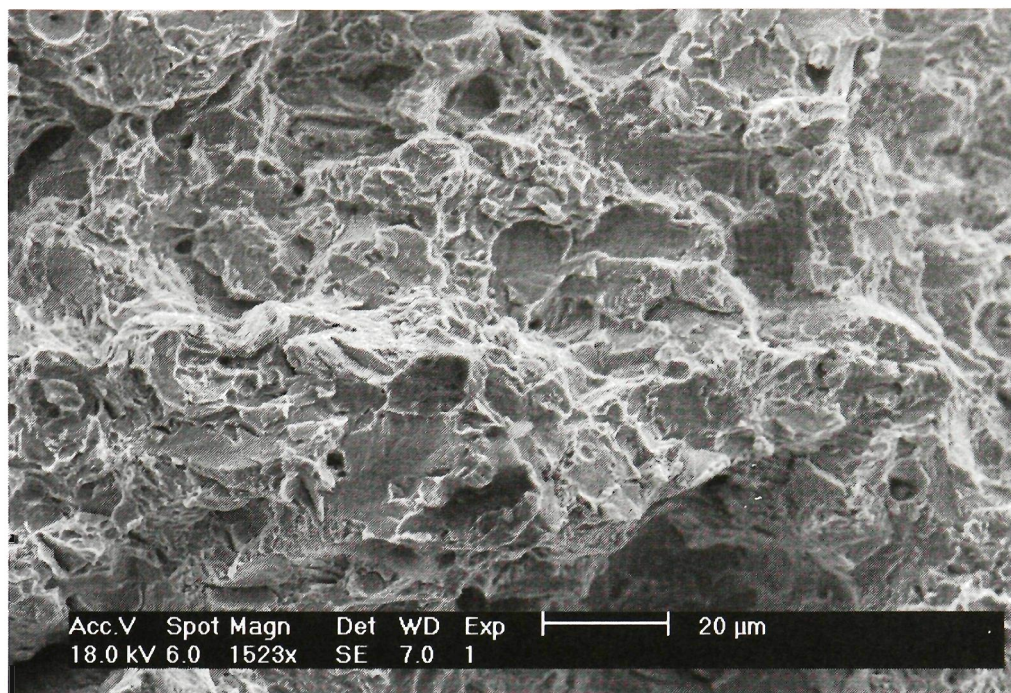
FIGURE 5.64: Typical SCC topography (damaged)

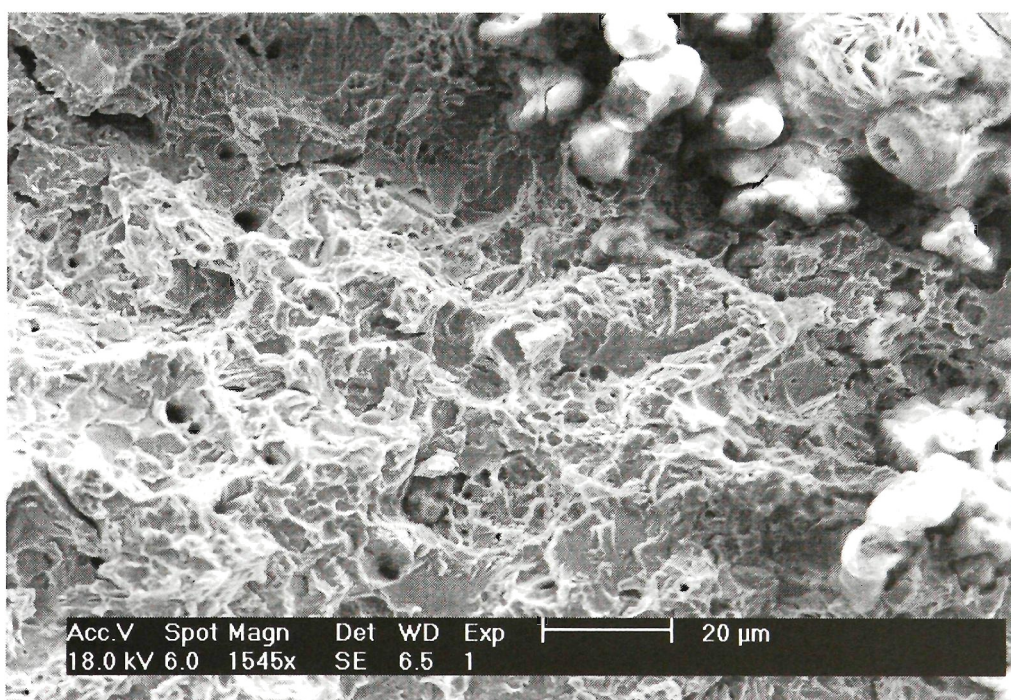
FIGURE 5.65: Typical SCC topography (damaged)

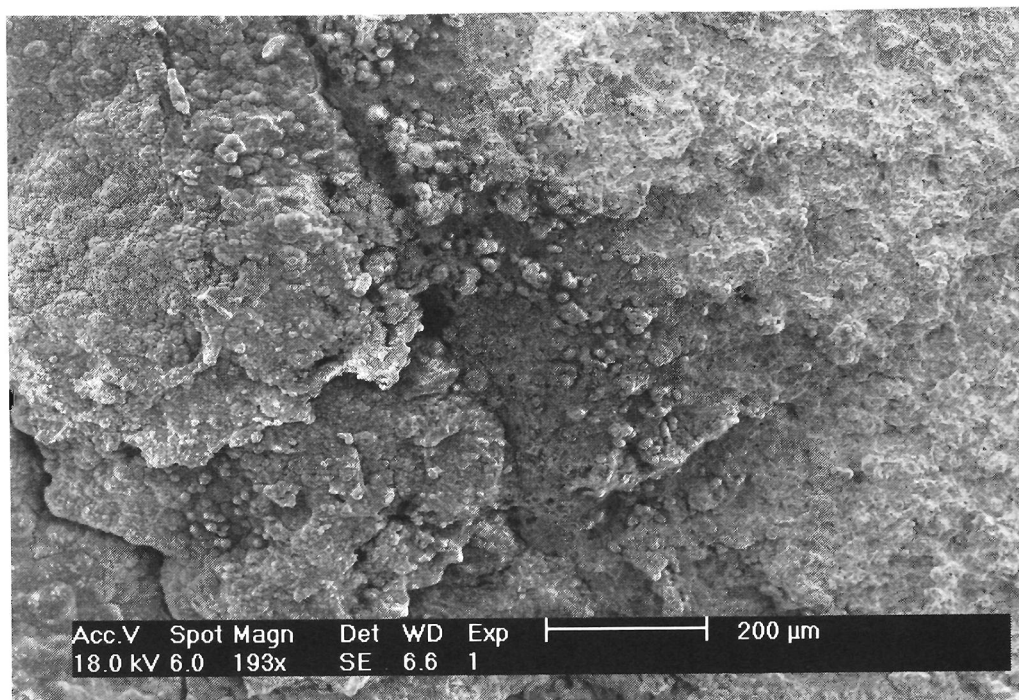
FIGURE 5.66: Damaged CIS - FFS interface

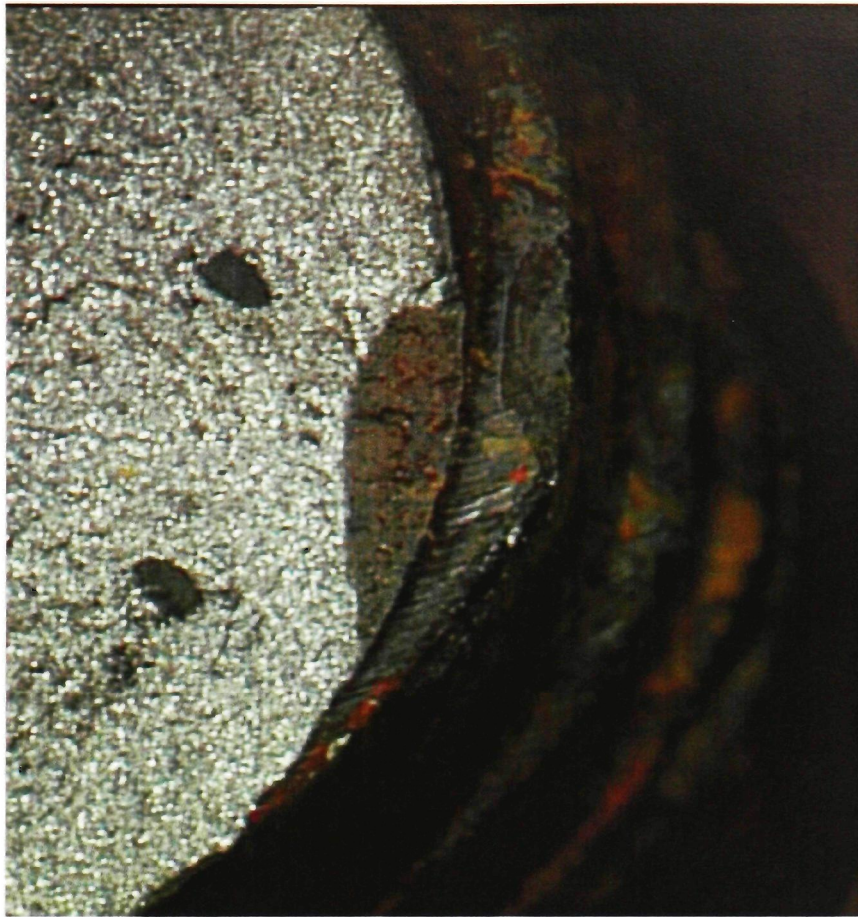
FIGURE 6.1: Overview of the dark thumbnail area on the rock bolt fracture surface.
